Recent northeast Italian tornado events: lesson learned for improving structures

Alessio Pipinato¹

Abstract Increasing intensity and frequency of tornadoes have been reported in Europe in the last decades, and in Italy, in particular in the northeast area, including Veneto, Friuli Venezia Giulia and Trentino Alto Adige. The public consciousness and the meteorological control of this risk are sufficiently established in the USA. The European continent and the northeast of Italy do not exhibit a similar state, although the tornado damages induced are increasing and becoming of economic relevance. Studies and research are diffused and have reached a detailed level, being able to correlate tornado intensity to a detailed damage state for a wide amount of building classes. But, codes and standard, both in USA and in the whole European continent, have not been developed for tornado loadings. For this reason, to fill the gap between studies, research and observational data, in this study Italian wind extreme events are presented and discussed first. In a second part, the damage assessment results of the most extreme events recorded in the northeast of Italy (from F3 to F5, Fujita scale)

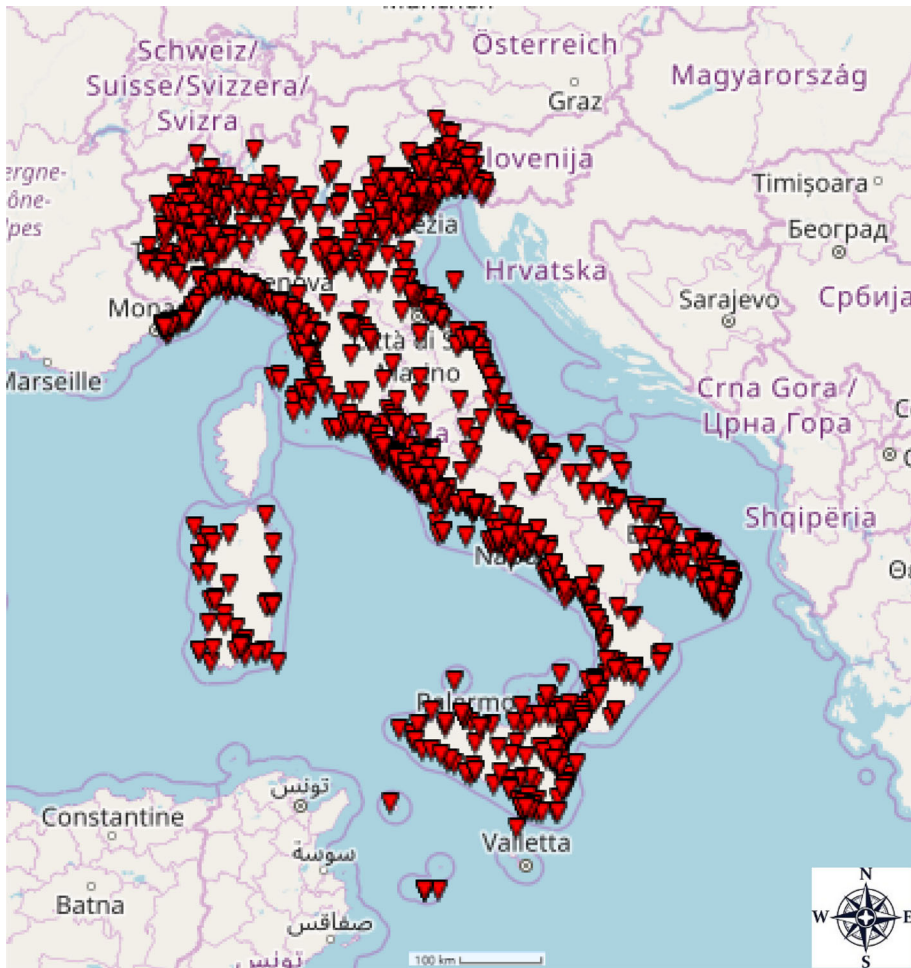
Fig. 2 Tornadoes recorded from 1905 to 2017 in Italy, 1,323 recorded events (ESWD 2017)

A research about historical tornado events is presented in the first part of this study, to provide relevant information for tornado hazard assessment in the northeast of Italy, as this is one of the most prone regions (Fig. 2). In the second part of the paper, the damage assessment of the buildings hit by the 1905–2017 events of the northeast of Italy is presented, providing building rating by means of a damage observational index. Observed damage is described in detail, analyzing the structural types involved and the presence of weak/vulnerable elements. In the third part, structural codes and common vulnerabilities are discussed. Finally, in the fourth and last section, a tornado-resistant building classification is presented basing onto the analysis of hundreds of records of northeast of Italy events analyzed in the study.

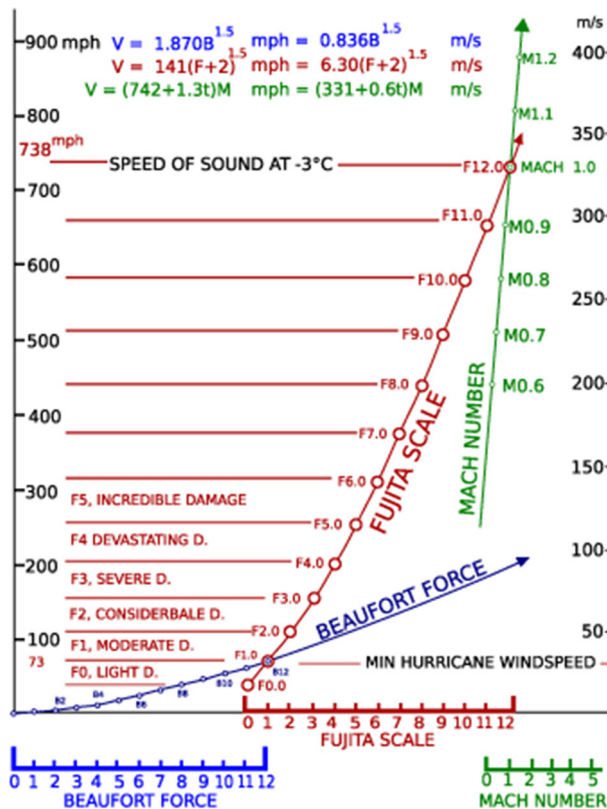
Fig. 9 Relationship among Beaufort force, Fujita scale and Mach number

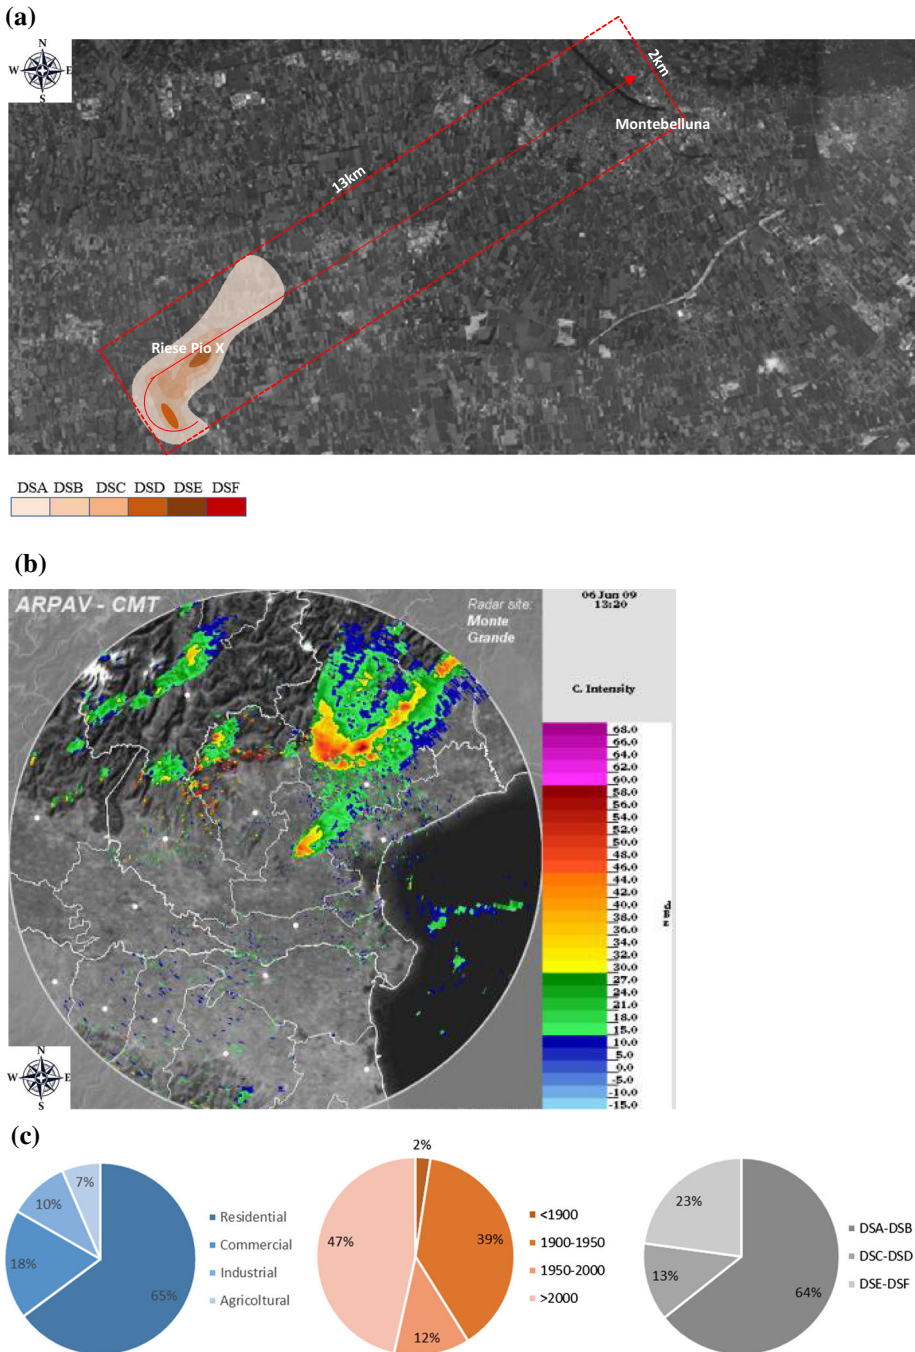
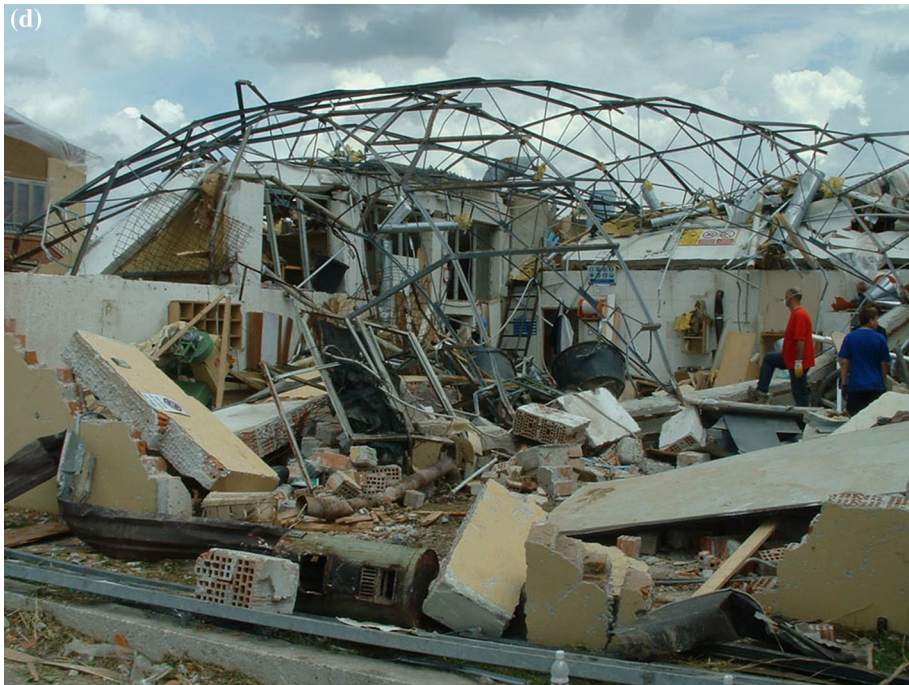
This tornado caused great damage to the village of Vallà of Riese Pio X, in the province of Treviso. The destructive path of the tornado is reported in Fig. 12a, together with the building damage map according to the adopted DS classification and the associated Gaussian probability density function (a geostatistical procedure that generates an estimated surface from a scattered set of damage points with DS-damage values). In Fig. 12b, the radar image of the storm is depicted. The recorded path was nearly 13 km, with 2 km as maximum width. However, a more extended area was hidden by this event (112 km). In this case, the tornado damage was not so extended, but particularly concentrated in a zone (the Vallà city): the majority of the analyzed buildings (64.36%) were subject to moderate damage (DSA–DSB), whereas 12.8% to slight damage (DSC–DSD) and 8.9% suffered by extensive damage or structural collapse (DSE–DSF) (Fig. 12c, d). No victim and thirty injuries were reported. The most damages reported were: roof discover, electric plant and public illumination out of use, instability of buildings under construction, light structure leveled, old masonry building partially demolished, large devastation of agricultural cultivation, etc. The documents used to derive this damage survey are: ARPAV (2009),

Fig. 12 Riese Pio X event, F3 (June 6, 2009): **a** the reconstruction of the tornado pathway, with a colourmap Gaussian interpolation of the expected most damaged zone; **b** the radar image of the storm (ARPAV 2015); **c** building use, construction year and damage category; **d** DSE-DSF areas, main damages

Place	Year	Fujita scale	DSA-DSB (%)	DSC-DSD (%)	DSE-DSF (%)	Path length	Path width	Injured	Death	Actualized damage estimates	Reported maximum wind speed (km/h)
Riese Pio X	2009	F3	64.36	12.80	22.84	13.00	2	30	0	12,000,000.00	270–320
Adria	1953	F3	0.00	83.33	16.67	13.00	n.a.	n.a.	n.a.	1,620,000.00	250–270
Melara	2014	F3	66.10	19.60	14.30	9.50	n.a.	4	0	1,500,000.00	250–270
Venezia	1970	F4	72.59	0.66	26.75	65.00	n.a.	500	36	54,740,000.00	340–350
Mira	2015	F4	76.70	14.40	8.90	10.00	1.1	84	1	70,000,000.00	340–350
Montello	1930	F5	58.07	21.56	20.37	80.00	0.3–0.09	100	23	n.a.	420–460

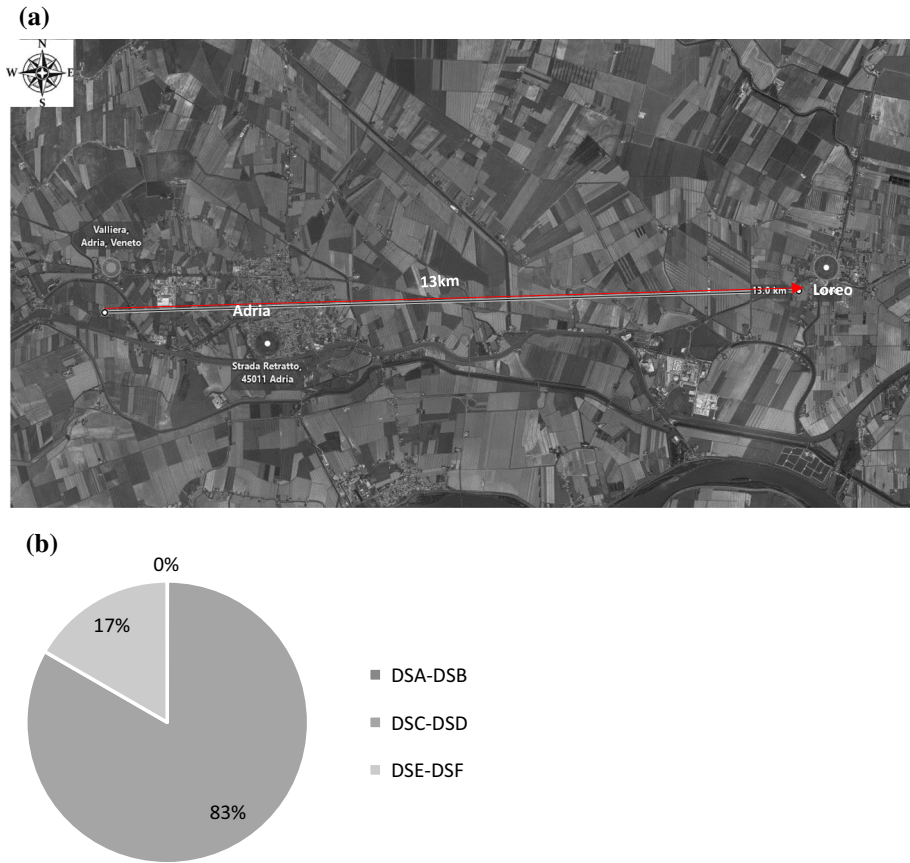
Historical newspapers reported that a violent tornado fell between Valliera, Retratto (Adria) and Loreo, (13 km path length). The destructive path of the tornado is reported in Fig. 13a. Most of the damages (83.33%) analyzed buildings were subject to slight damage (DSC), 10.42% suffered by extensive damage DSE, and structural collapse in 6.25% (DSF) (Fig. 13b). The most damages reported were: roof extended damage (complete peel) and total removal of the roof especially for farm structures in isolated position outside the inhabited areas. Large damage has been reported also for cultivation in the nearest of the tornado path. The documents used to derive this damage survey are: Abinanti et al. (2015), Historical Archive of the Adria Municipality (2017) and Gazzettino (2017).

Fig. 13 Adria event, F3 (August 24, 1953): **a** the reconstruction of the tornado pathway; **b** building damage estimated category

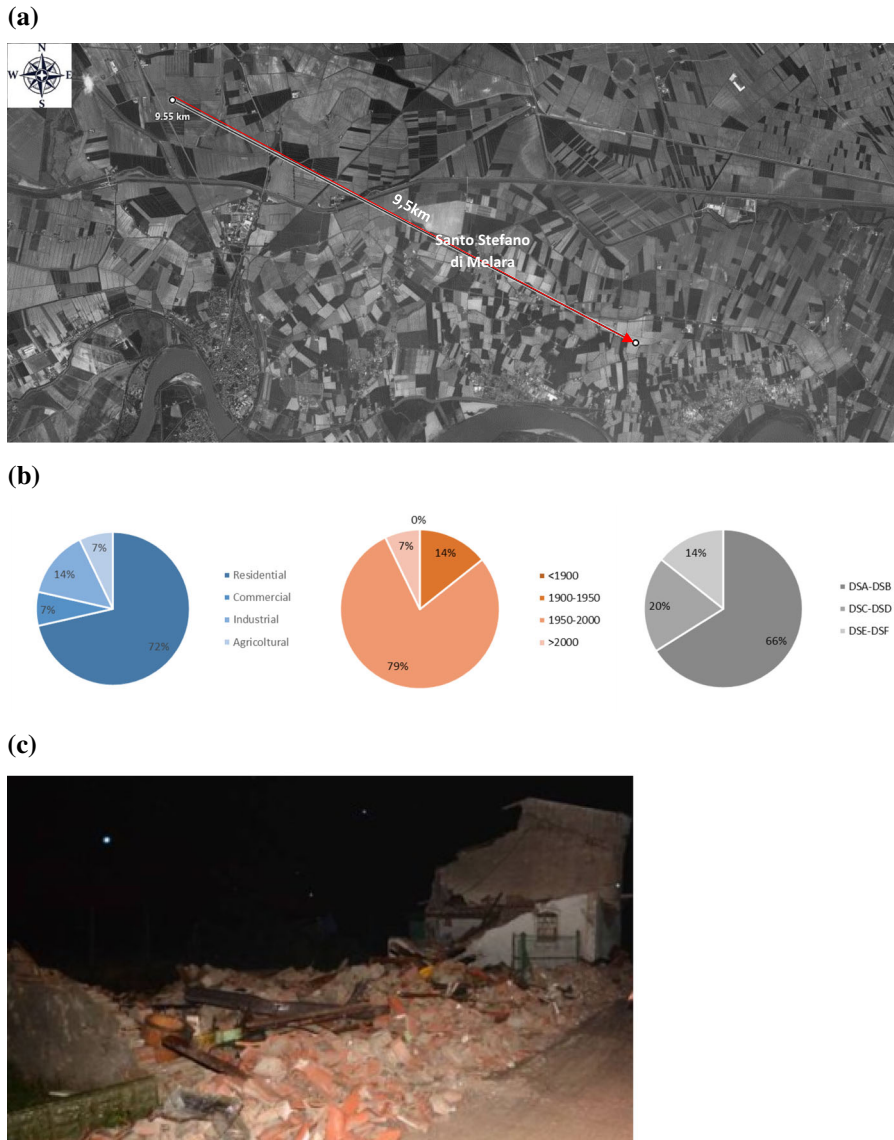
tornado paths, probably involved in a very large wind-storm event. The path simulation of the tornado according to the damage reported is depicted in Fig. 14a. The tornado path was characterized by a length of about 9.5 km, with localized damages in the San Francesco di Melara city: no damages were reported in the nearest as a wide countryside is all around, without buildings. Most of the analyzed buildings (66.1%) were subject to moderate damage (DSA–DSB), whereas 19.60% to slight damage (DSC–DSD) and only 14.30% suffered by extensive damage or structural collapse (DSE–DSF) (Fig. 14b). The most damages reported were: slight damage to roofs and minor structures (agricultural small and light structures) and roof extended damage (partial or complete peel). Minor construction also has been hidden by the event, inducing rotations of small wall and distortion of high and slender steel structures. The documents used to derive this damage survey are: ARPAV (2014) and Gazzettino (2017), photograph archive of the author.

Fig. 14 Melara event, F3 (October 13, 2014): **a** the path of the tornado; **b** building use, construction year and damage category; **c** DSF areas, main damages

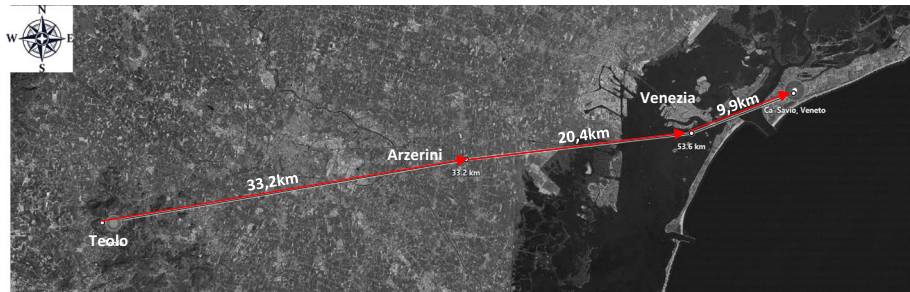
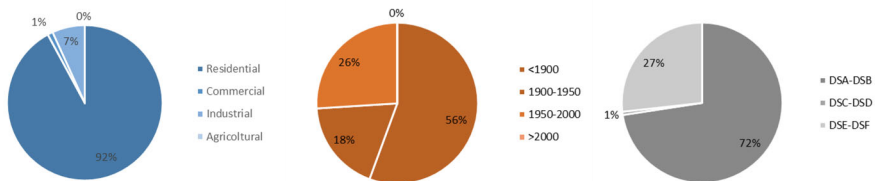
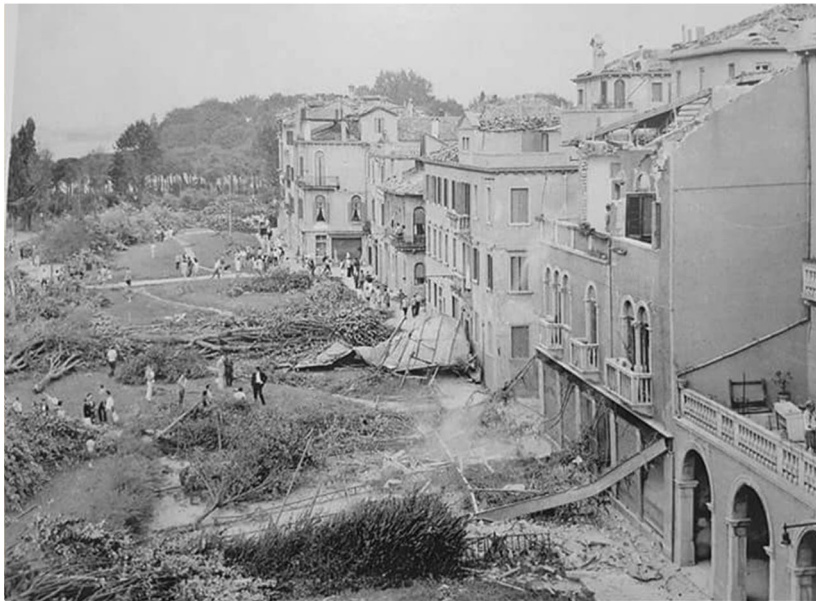
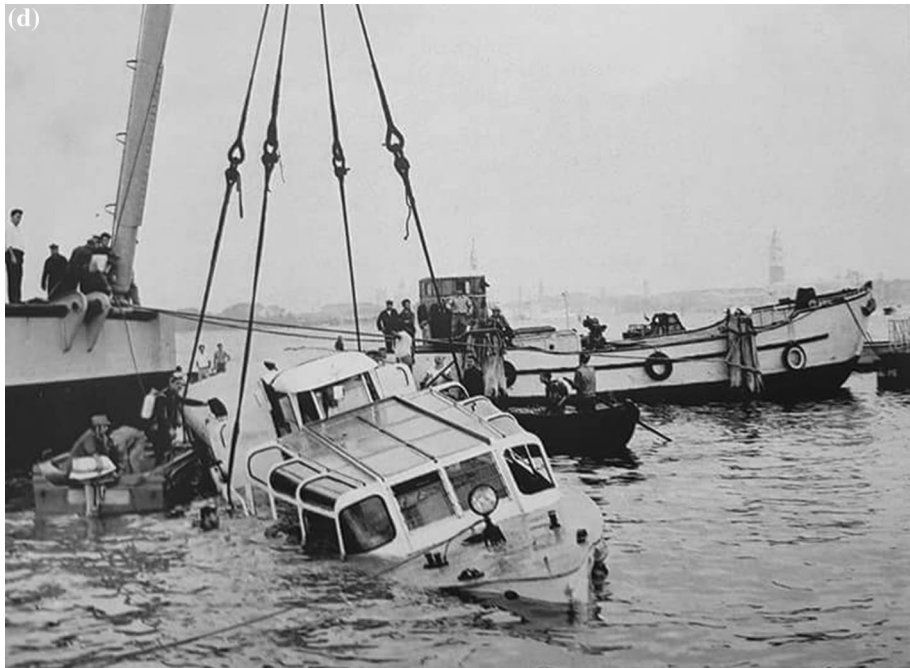
tornadoes ever observed, not only in the area but on the entire Italian peninsula, with the highest number of death (36) and injured people (500). A very long path—65 km—characterized this tornado (Fig. 15a): starting in the nearest of the Euganean hill (Teolo),

Fig. 15 Venezia event, F4 (September 11, 1970): **a** the path of the tornado; **b** building use, construction year and damage category; **c** DSF areas, main damages

the path touched Padova, Albignasego, Ponte San Nicolò, Abano, Selvazzano, Campoverardo di Camponogara, San Bruns di dolo, Giare, Dogaletto, Fusina, then prosecuted in the Venice lagoon devastating the Grazie Island and the Lido island, leaving damages also in the city of Venice, and then Saint Elena Island, terminating at Cà Savio. The majority of the damages (72.59%) buildings were subject to moderate damage (DSA–DSB), 0.66% suffered by slight damage DSC–DSD, and extensive damages in 26.75% (DSE–DSF) (Fig. 15b, c). The most damages reported were: roof extended damage (partial in the nearest of the path, complete peel for building along the path wherever the complete collapse was not induced); the Fusina camping was completely destroyed; the electrical plants and devices, including the public illumination, were completely destroyed; the Grazie Island hospital was completely destroyed; a large ship (the ANCIL) was completely lifted up and sunk with the complete crew (21 persons); then returning into the landside, the tornado completed demolished the naval academy “Morosini,” the “Penzo” stadium, the “Nicelli” airport, the Ca Savio camping. The documents used to derive this damage survey are: Abinanti et al. (2015), State Archive of Venice (2017) and Gazzettino (2017).

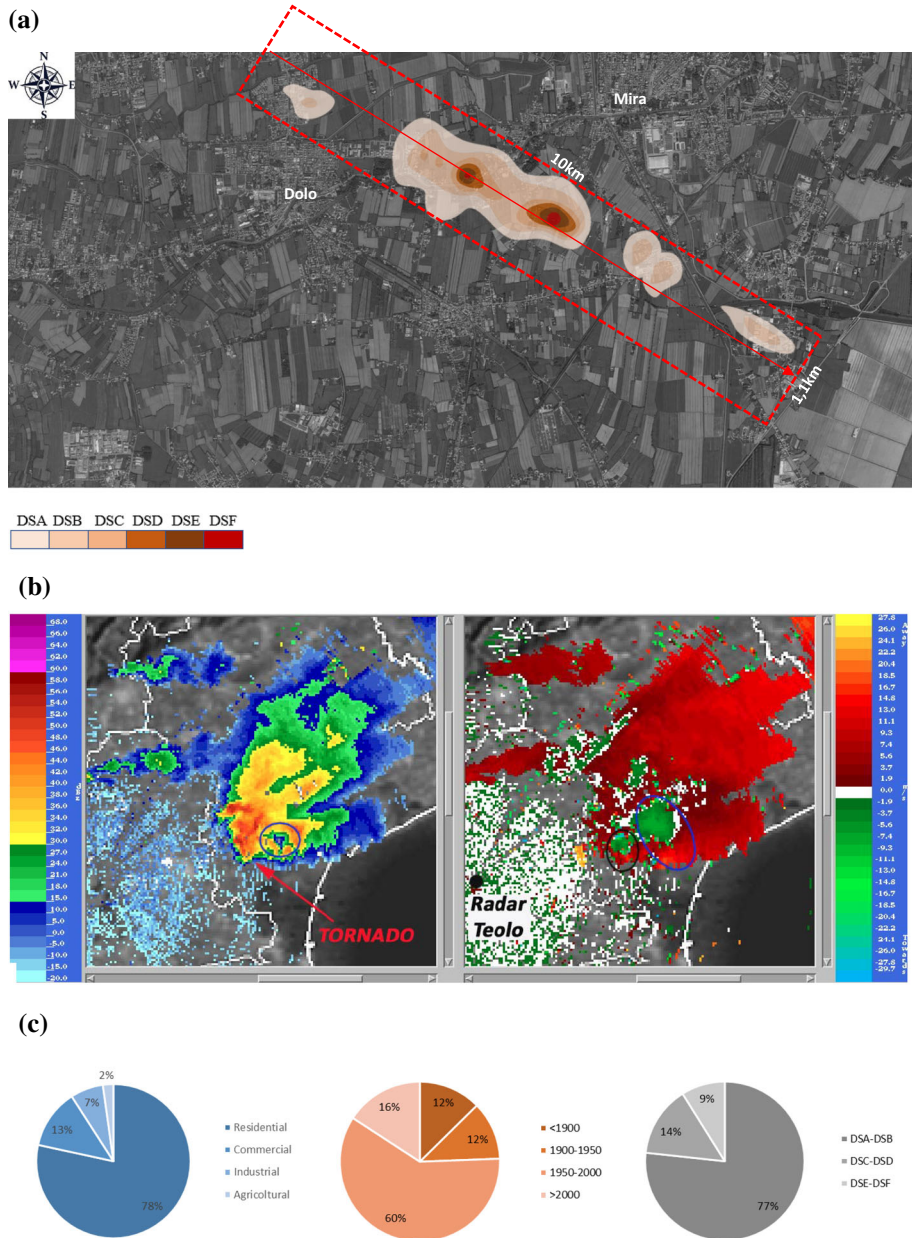
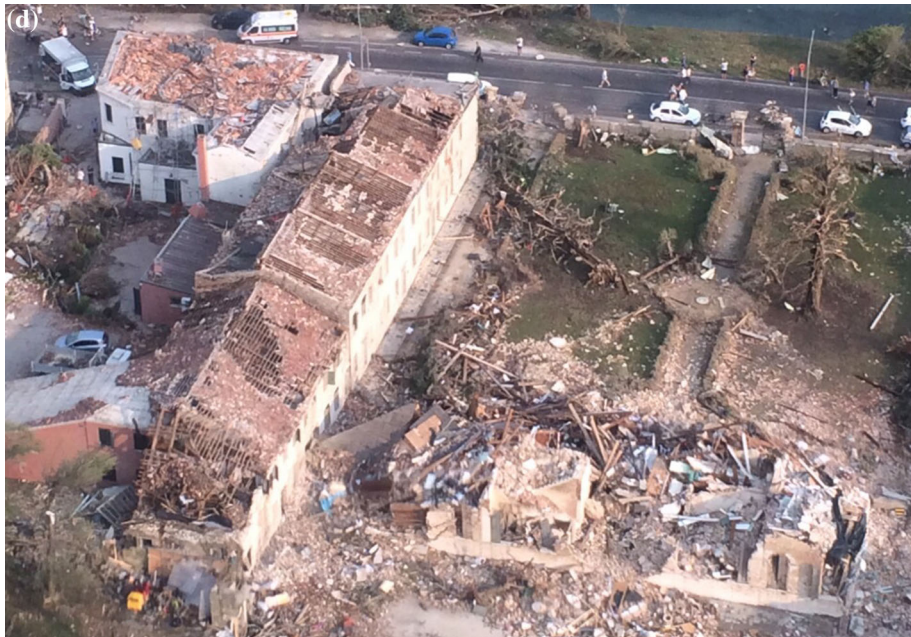
A very similar event of the Venezia event in 1970 was recorded in 2015. One victim and 84 injuries were reported. The most hidden cities were Pianiga, Mira and Dolo. The destructive path of the tornado is reported in Fig. 16a, together with the building damage map according to the adopted DS classification and the associated Gaussian probability density function. In Fig. 16b, the radar image of the storm are depicted. The path length was approximatively of 10 km, with a maximum width of 1.1 km. The majority of the

Fig. 16 Mira event, F4 (July 8, 2015): **a** the path of the tornado with a colourmap Gaussian interpolation of the most damaged zone; **b** the radar image of the storm: reflectivity PPI at 2.5° on the left (ARPAV 2015); **c** building use, construction year and damage category; **d** DSF areas, main damages

analyzed buildings (76.7%) were subject to slight damage (DSA–DSB), whereas 14.4% to moderate damage (DSC–DSD) and only 8.9% suffered by extensive damage or structural collapse (DSE–DSF) (Fig. 16c, d). The most damages reported were: the complete destruction of historical buildings and rural villas, large roof discovering including masonry walls elevation on the upper part of the buildings, cars and light structure lifted up, complete destruction of public electrical towers and antennas, tree devastation. The documents used to derive this damage survey are: Abinanti et al. (2015) and Gazzettino (2017), photograph archive of the author.

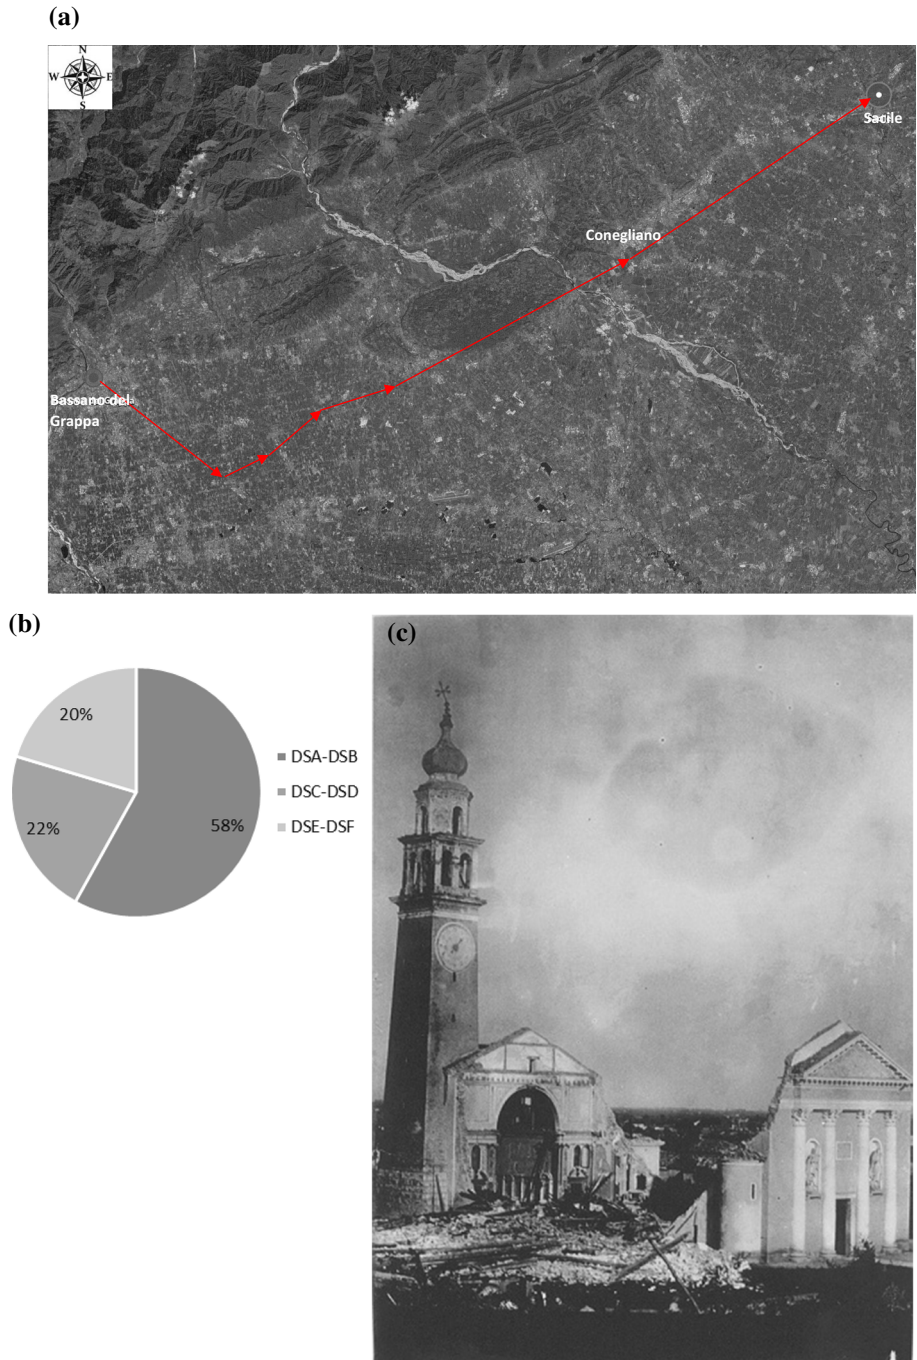
On July 24, 1930, the city of Montello in the northeast of Italy, in the southern of the Alps, was hit by the strongest tornado in Europe on record. The tornado was rated as F5, destroying whatever was in the path (e.g., large masonry buildings like churches). The Montello tornado persisted for 1.5 h and produced a damage track 80 km long, roughly between Treviso and Pordenone, causing 23 fatalities (Fig. 17a). The long damage track and persistence of the tornado suggest that this event may have been caused by several tornadoes produced by the same cyclic supercell. The tornado originated in the nearest of Bassano del Grappa, passing by Castello di Godego, Vallà di Riese, Caselle di Altivole, Sant'Andrea di Montebelluna, Sant'Eurosia di Volpago, Nervesa, Susegana, Conegliano, Sacile, ending around the Cellina river near Pordenone. Everything in the path was destroyed: the main buildings (58.07%) were subject to moderate damage (DSA–DSB), 21.56% suffered by slight damage DSC–DSD, and extensive damages in 20.37% (DSE–DSF) (Fig. 17b, c). The most damages reported were: the complete destruction of houses, the collapse of the Selva church demolishing the complete longitudinal walls and the roof,

Fig. 17 Montello event, F5 (July 24, 1930): **a** the path of the tornado; **b** building damage estimated category; **c** DSF areas, main damages

house's roof was peeled completely in the nearest of the tornado path, and agricultural cultivation was devastated; moreover, missiles (mostly flying roof, or masonry and wood-beam coming from the devastation of were observed. Along a width of 300–900 m (depending on the tornado position) all was devastated and lifted also for kilometers of distance. The documents used to derive this damage survey are: Abinanti et al. (2015), Zanardo (2015) and Gazzettino (2017).

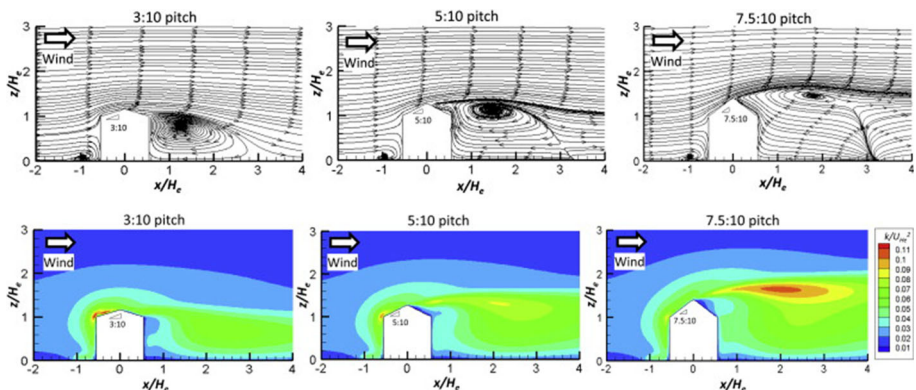
Figure 18 schematically shows the interaction between the airflow and a generic building profile, highlighting that the direction and pressure intensity mainly depend on the inclination of the roof pitches (Tominaga et al. 2015). Various types of tornado simulators have been built in the past to create tornado-like vortices in the laboratory and study the vortex dynamics by varying the controlling parameters (Ward 1972; Snow and Lund 1988; Monji and Wang 1989; Church et al. 1979; Haan et al. 2008; Matsui and Tamura 2009; Hashemi-Tari et al. 2010). However, although the increasing experience on tornado simulations, limited attempts have been made to quantify tornado-induced loading. Case et al. (2014) investigated the effect of different building geometry on the forces and pressures that low-rise buildings would experience in a simulated tornado with a swirl ratio comparable to what has been measured and recorded for full-scale tornadoes. Measured force and pressure data were then used to judge whether tornado-resistant design for residential structures is feasible. The tornado-induced wind loads were measured on scaled models of buildings in a laboratory-simulated tornado with a core diameter (56 m) and relatively high swirl

Fig. 18 Interaction between airflow and a generic building profile Adapted from Tominaga et al. (2015)

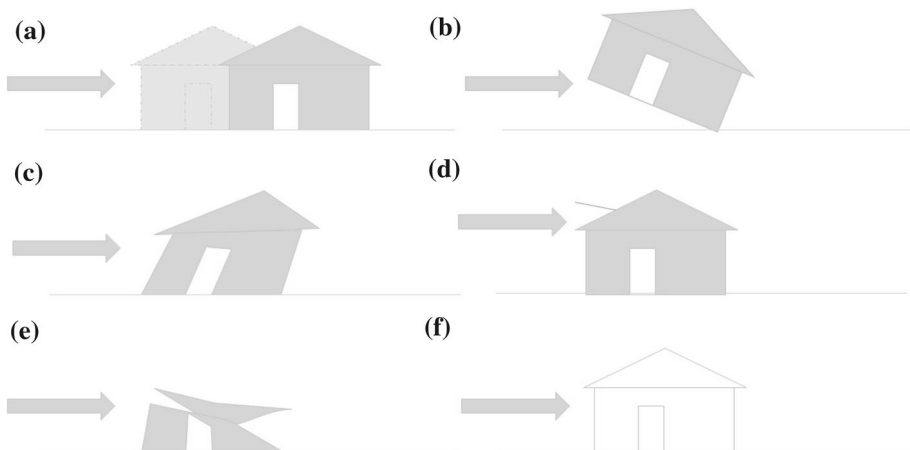
The main failure modes due to the action of tornado on existing constructions for buildings are (Fig. 19):

- (a) translation or sliding,
- (b) overturning,

Fig. 19 Main failure modes due to the action of tornado on existing constructions for buildings

- (c) racking
- (d) material/component failure,
- (e) incoming collapse
- (f) total destruction.

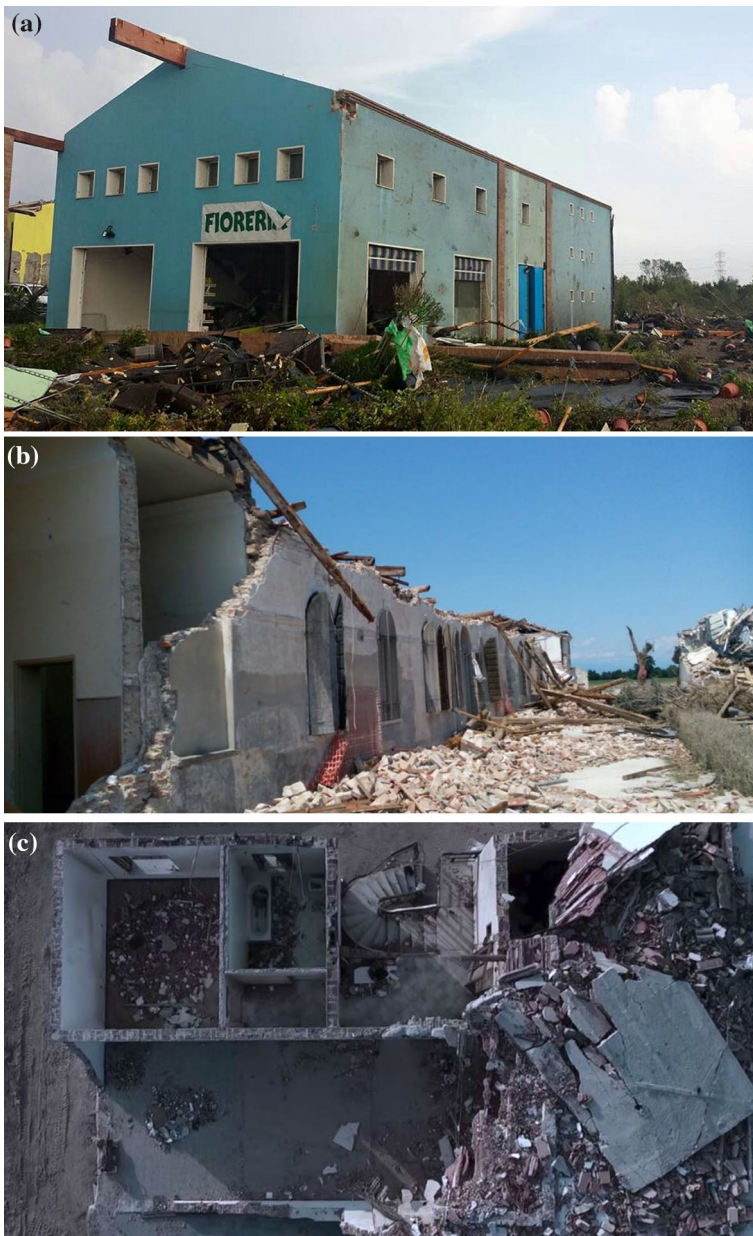
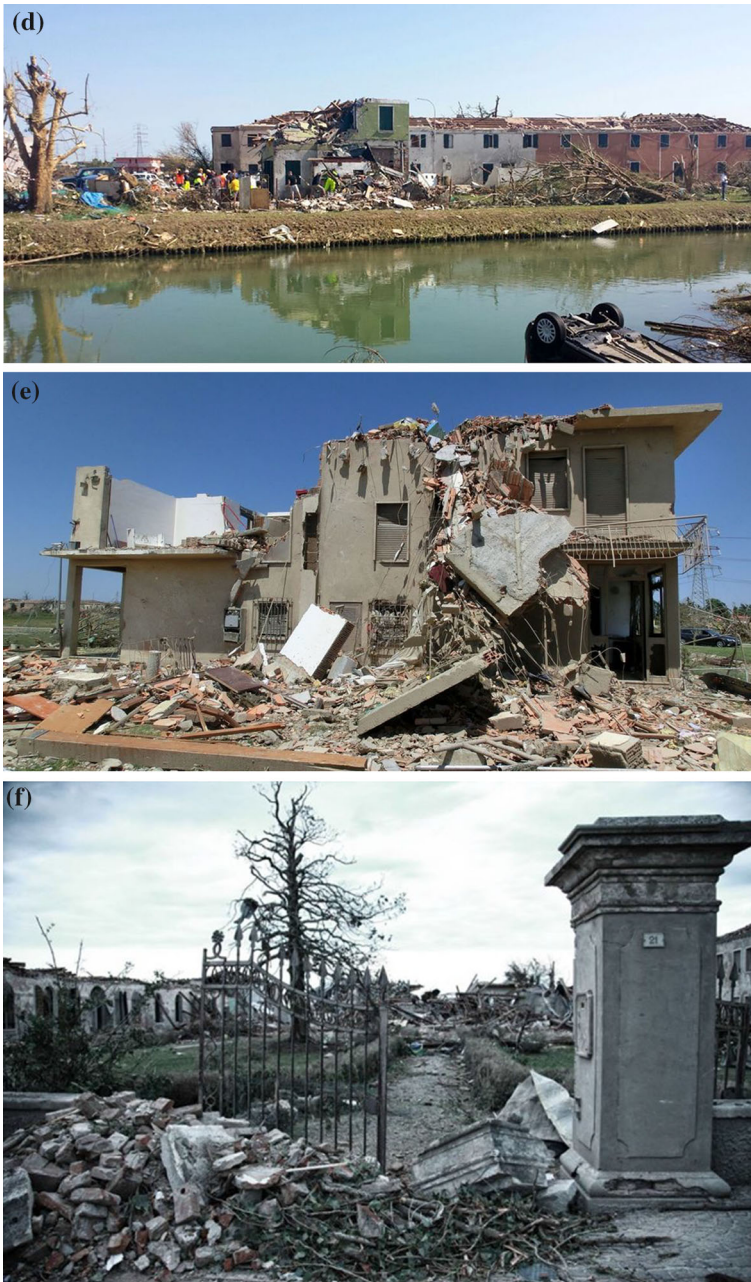
All these failure modes could be observed both in the recent USA and Italian events, however, depending on the tornado wind force, an increase in the damage loss could be observed. Differences depend mainly on the construction types differentiating USA and Italy: e.g., the diffused wooden houses in USA are often damaged and may be broken also by EF1–2 events, while in Italy where masonry or R.C. frame (reinforced concrete frame) represents the majority of housing constructions, EF3–EF5 are needed to reach the total destruction state. Not only the building type (e.g., the lightness of wooden construction if compared to masonry building) makes US construction more vulnerable to tornadoes, but also the typical construction details of wooden structure diffused in USA (discontinuity between foundation and elevation, discontinuity between roof and elevations of) contribute to this trend. And this is applied also for Italian historical buildings of 500–1000 years of service life (which is not a feature of USA) with massive and heavy typical features. Italian common incremental damages, depending on the increasing EF scale wind action, are mainly represented by roof components failures, upper walls failures, internal devastation, lastly going to the inferior part of the perimeter walls. Examples of every incremental damage observed in the recent events are depicted in Fig. 20. It should be concluded that:

- (a) constituent material of structural components could influence both the failure mode, the increasing wind resistance, and the capacity to protect consequently the inhabitants; for this reason, R.C. or masonry buildings showed to be more suitable if compared with wood structures;

- (b) connections among structural components is a crucial question, for every type of building; wooden, masonry or R.C. buildings could be seriously damaged if joint are unable to connect the single substructures; internal joint among macro-elements (e.g., roof-upper walls, walls/foundation), but also joint among micro-elements (e.g., brick-to-brick interface in old masonry structures, with a very low content of cementitious materials);

- (c) connections among non-structural components are relevant to maintain the building in use in the aftermath and at the same time to ensure the structural functionality; connections between roof cover/upper slab, drainage systems and upper walls are prone to damage seriously even with low wind speed events.

Fig. 20 Incremental damage observed in the recent Italian events: **a** translation or sliding; **b** overturning; **c** racking; **d** material/component failure; **e** incoming collapse; **f** total destruction

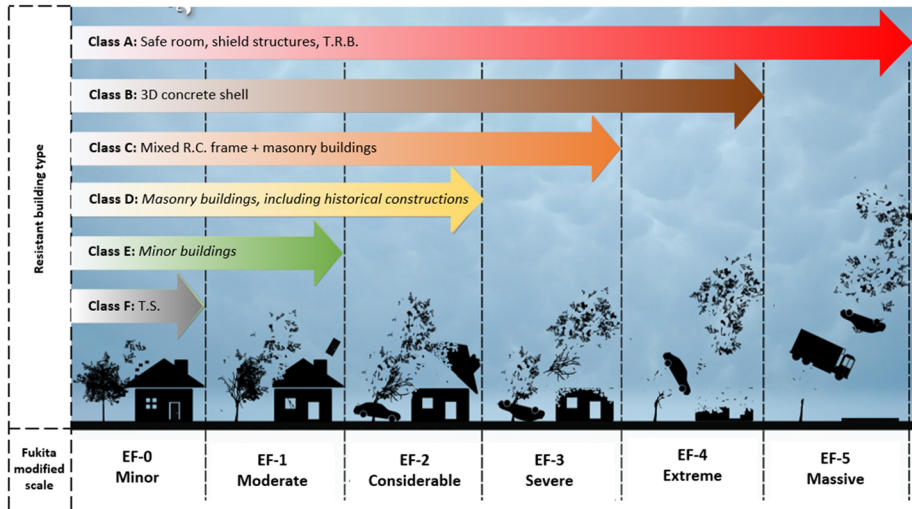
A wide amount of research on the designs and practices of tornado-resistant homes exists; however, there is a gap in illustrating alternatives of new construction or retrofit of existing buildings correlating the building technology to the EF Fujita scale of the hypothetical event. The most common resistant building alternative are presented hereafter comparing the building class to the northeast of Italy existing situation. A graphical synthesis of the category class of these building is shown in Fig. 21: every building class is considered to be effectively resistant until the use of inhabitants is ensured, consequently, e.g., while for the F-class the use of the building has been evidenced to be safe only for a EF0 event, the use of A-class building could be considered safe for whatever EF grade.

Fig. 21 Tornado-resistant building to a selected EF Fujita scale event, basing onto northeast of Italy events observed in the study
