### Fatigue tests on riveted steel elements taken from a railway bridge

To cite this article: Alessio Pipinato, Marco Molinari, Carlo Pellegrino, Oreste S. Bursi & Claudio Modena (2011): Fatigue tests on riveted steel elements taken from a railway bridge, Structure and Infrastructure Engineering, 7:12, 907-920

## Fatigue tests on riveted steel elements taken from a railway bridge

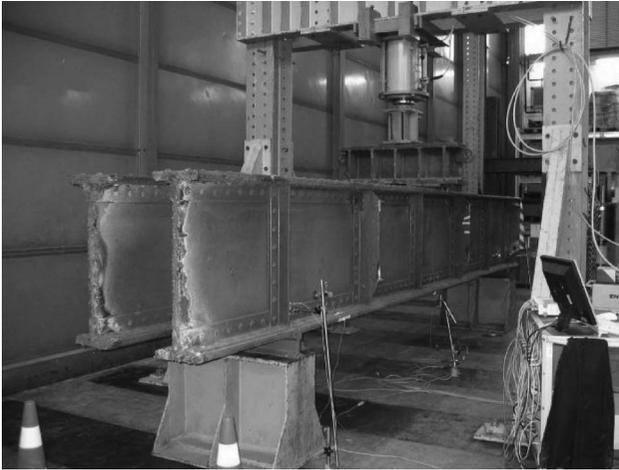
Figure 5. Overall view of the BLC1 test.

Laboratory of the University of Padua. In the first test, BLC1, a three-point bending scheme and 5.0 m of free span were considered, as shown in Figures 4 and 5. The load was applied by means of a hydraulic jack approximately at the centre of the specimen. Out-of-plane buckling of the panel web was observed at a

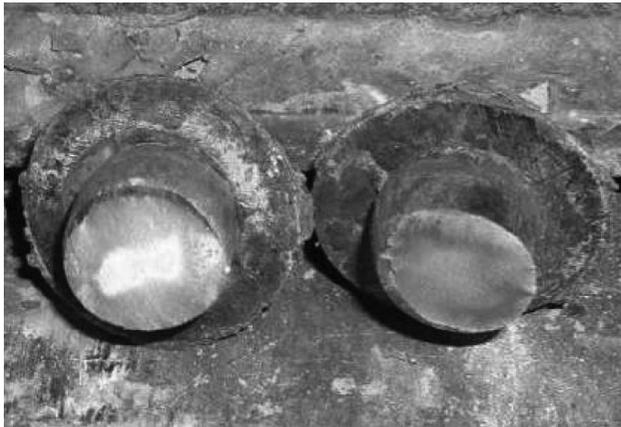
Figure 9. A failed rivet of the SLC test on short-diaphragm riveted shear connections.

Monotonic test data highlighted a quasi-linear behaviour up to 900 kN and a failure load of 1060 kN. Failure occurred in the middle of the shank of rivets located at the second and third rows (see Figure 9) corresponding to a shear stress value of about 470 MPa. No significant damage was detected in the base material.

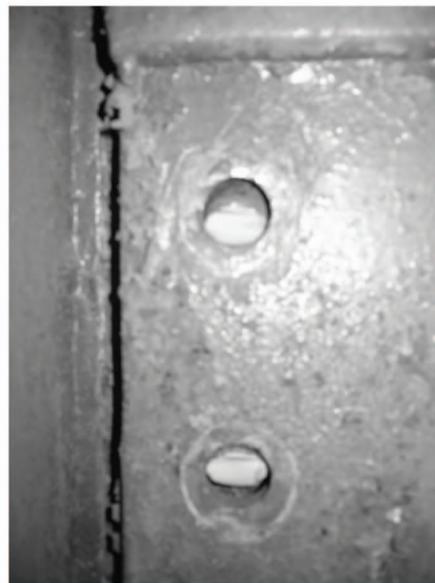
Figure 12. Laboratory fatigue SHC test: (a) test set-up and (b) the shear diaphragm after the rivets failure (the dimensions are in  $\times 10^{-2}$  m).

In order to reduce the test duration, the widest load range resulting in an elastic stress state was applied. With this aim, a 1000 kN actuator endowed with a 850 litre/minute oil flow servo-valve was employed, operating a force control at a frequency between 5 and 8 Hz; some days were required to reach rivet failure. Based on the maximum resistance of about 1060 kN, observed in the static test without any significant plastic deformation, upper load levels in the range 700–900 kN were applied. According to the actual loading, only compressive forces were applied, and the minimum load of 100 kN was always maintained, preventing the specimen decompression and any gaps. The test protocol and main results are summarised in Table 2. In detail, the first specimen was loaded in the range 100–900 kN and failed at 184,000 cycles; the second in the range 100–800 kN and failed at 560,000 cycles; the third in the

range 100–850kN and failed at 208,850 cycles; the fourth in the range 100–700 kN and failure was reached after 504,500 cycles. All results conservatively neglect cycles deriving from the previous service life because these cycles produced stress variation significantly lower than those obtained during the test. In all tests, failure occurred in rivets and resulted in the head popping off; after the first failure of a rivet, the other ones rapidly reached collapse owing to the increased shear stresses.  $S-N$  results are summarised in the Wohler diagram of Figure 13 with the literature data of Stadelmann (1984) and Brühwiler *et al.* (1990). Moreover, all data are compared to the EC 1993-1-9 (CEN 2005) fatigue line corresponding to the detail Category  $C = 100$ , see §2, based on the analogy between rivets and non-preloaded bolts suggested by Di Battista *et al.* (1997). The actual fatigue resistance appears to be greater than values
